CFM Aircraft Limited

SERVICE BULLETIN No.: 12
ISSUE: 1
DATE: 14/07/98

SUBJECT	Rudder Fin Post				
MODELS AFFECTED	B, C & D Series Shadow, Streak Shadow & Star Streak				
SERIAL Nos AFFECTED	All				
COMPLIANCE TIME	Before further flight				
PURPOSE	To identify possible cracks in the top of the rudder fin post in the vicinity of the top of the rudder fin where the fin post enters the boom tube. Rectify where necessary.				
ACTION	<p>Remove the rudder fin post from the aircraft. Remove a small section of the covering material (20mm x 20mm) on both sides of the fin around the gusset and the fin post itself at the root (see attached drawing). Inspect for cracks. It is not necessary to replace the covering material after inspection provided that the all remaining fabric is fully glued to the surface of the gusset.</p> <p>In the event that a crack is present, the entire rudder fin post (Part T 147) must be replaced prior to further flight with a new Rudder Fin Post Assembly (Part T189)</p> <p>In the event that no crack is present, a strengthening sleeve (Part T 188) must be installed in the top of the fin post, prior to the aircraft's next annual inspection (Modification 40)</p> <p>Reco

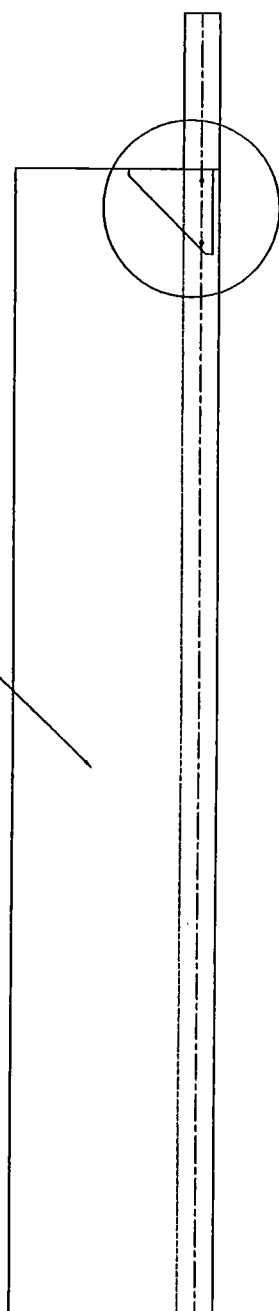
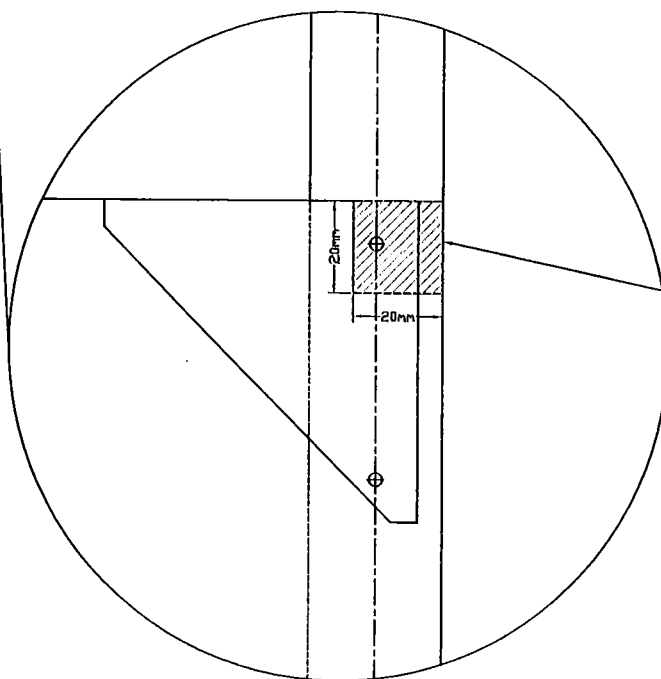
FIN
ASSEMBLY

COVERING TO BE
REMOVED FOR
INSPECTION

MATERIAL REQUIRED	Fin Post Insert (T 188); Rudder Fin Post Assembly (T189)				
AVAILABILITY OF PARTS	From CFM Aircraft				
EFFECTIVE DATE	16 JULY 1998				
ISSUED BY
