## MICROLIGHT AIRWORTHINESS APPROVAL NOTE

MAAN NO: 2073

TITLE: Microlight Airworthiness Approval Note 2073,  
Shadow Service Bulletin BMAA 2073.

<i>Title: Shadow variants: <b>Inspection of hanger tube brackets</b></i>	
<i>Reference: <b>SB BMAA MAAN 2073 issue 1</b></i>	<i>Applicability: <b>All UK Shadow variants administered by the BMAA</b></i>
<i>Issue date: <b>30 March 2007</b></i>	
<b>Recommend inspection.</b>	
<b>This SB should be actioned before the next Permit Revalidation inspection.</b>

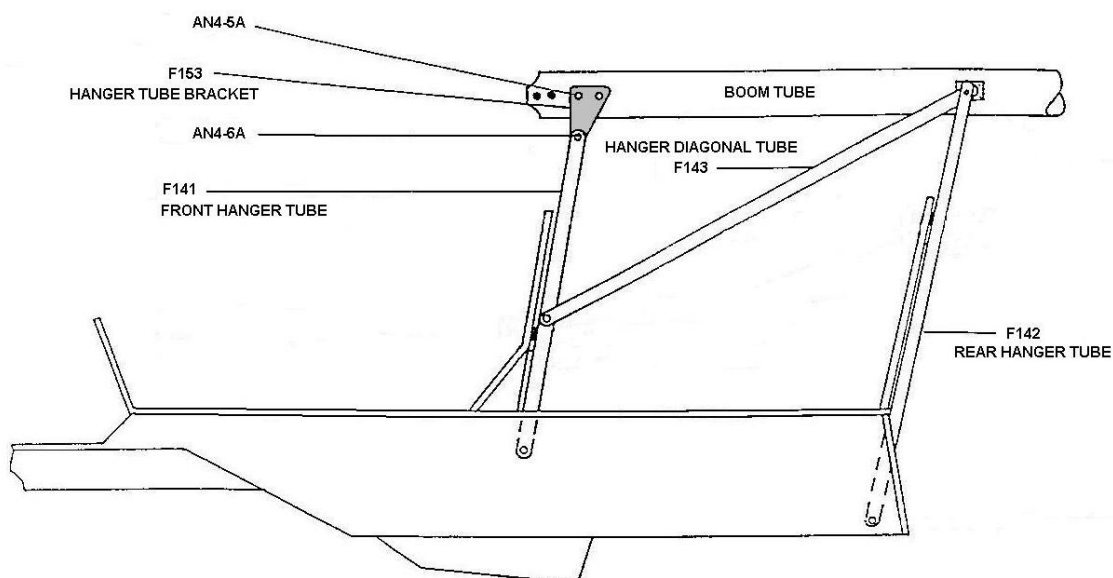
1. Firmly chock the main wheels to prevent them moving during the inspection.
2. From the rear cockpit, equipped with a good light source, inspect the F153 plates for cracks and any evidence of movement or fretting within the hanger tube and the bolts for tightness.

3. Whilst inspecting the plates, ask a helper to gently push the wing fore and aft and check visually, and by feel, for any signs of movement between the plate and the hanger tube.

4. Next try using a firm vertical force applied at the point where the wing strut attaches to the wing. **WARNING:** do not exert lifting pressures ant the wing tip.

5. Repeat steps 3 & 4 on the other wing.
6. Any evidence of undue movement or fretting should be investigated. If unsure, the F153 may be removed from the aircraft for a detailed inspection. If everything appears normal, then return the aircraft to service.

7. Any adverse findings should be reported to the BMAA.
