## MICROLIGHT AIRWORTHINESS APPROVAL NOTE

MAAN NO: 2329

TITLE: Microlight Airworthiness Approval Note 2329: Shadow Tailplane Spar and Bush Wear

**Reference:** BMAA Service Bulletin 2329 Issue 1  
**Title:** Horizontal tail plane spar wear  
**Applicability:** All BMAA-administered Shadows  
**Author:** B J Syson, Chief Technical Officer, BMAA  
**Effective date:** 21 March 2011  
**Classification:** Essential

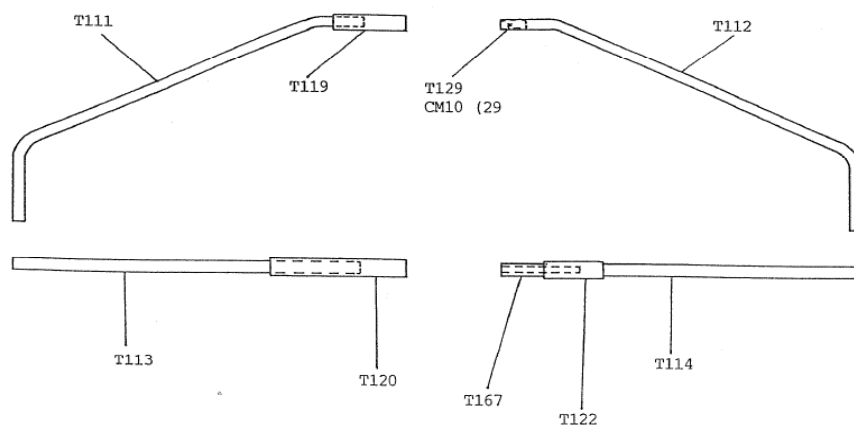
**Figure 1: Shadow horizontal tail plane structure**

Parts T119 and T120 are affected – see Figure 1. An example of extreme, and totally unacceptable, wear is shown in Figure 2. Two distinct wear patterns may be seen, caused by contact with the bushes and with the fuselage tube.

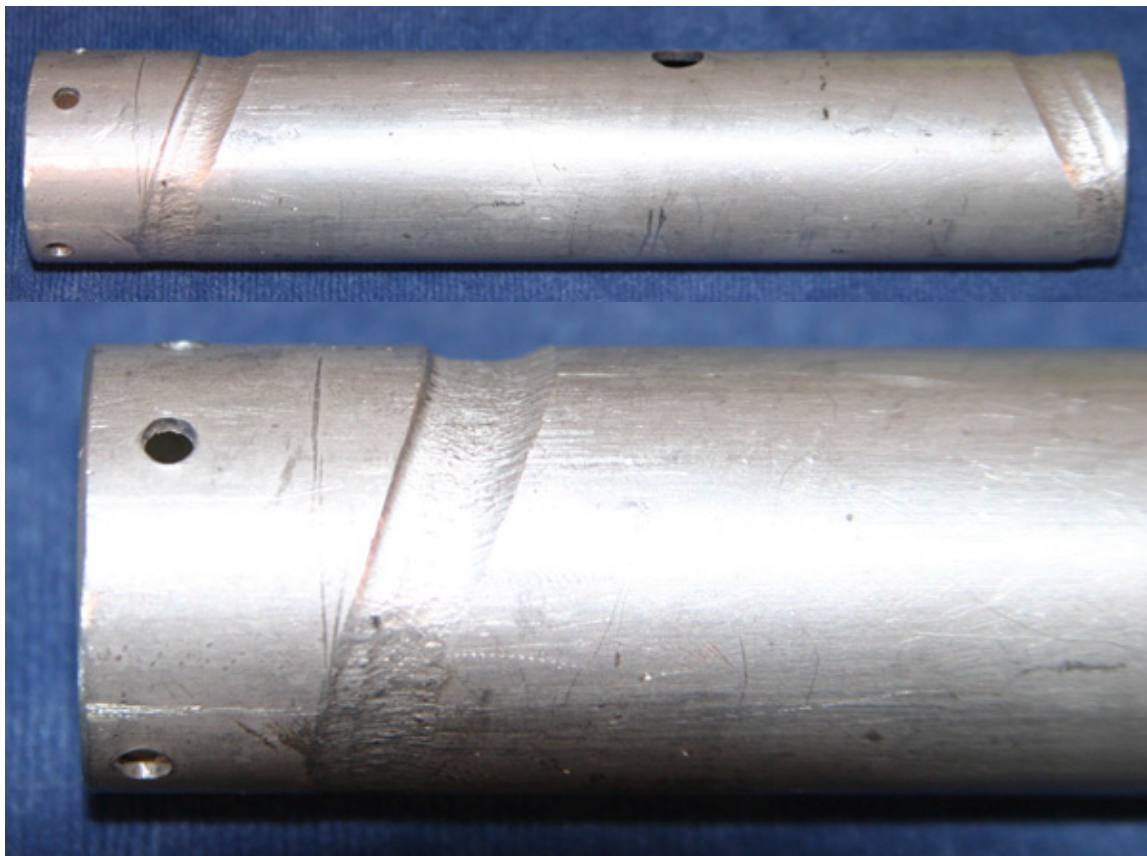
The tail plane spars are sleeved where they pass through the fuselage tube. The port rear spar sleeve has been determined to be the critical case. Wear in excess of 0.73mm has been calculated to be critical from a bending strength perspective. The Service Bulletin limits acceptable wear to 0.6mm at the four wear points.

**Figure 2: an example of extreme, totally unacceptable wear**

Within **10 flight hours or 3 months** of the effective date (whichever is sooner), and then at least every **50 flight hours or annually** (whichever is sooner), the horizontal tail plane must be de-rigged to inspect the tail plane spars directly. Measure the wear on the spar sleeves; this is best performed using a steel rule laid edgewise along the spar (to provide a straight edge parallel to the undamaged surface) and then the depth measured using a vernier caliper's depth probe. Note: it is the wear below the surface that should be measured, not the reduction in diameter.

***Wear of the spars in excess of 0.6mm (0.024") is totally unacceptable from a strength perspective.*** However wear less than this may also be unacceptable if (possibly combined with wear of the locating bushes) it results in significant 'slop'.

Any repairs must be made in full accordance with BMAA procedures – contact the BMAA Technical Office.
