MICROLIGHT AIRWORTHINESS APPROVAL NOTE

MAAN NO: 2336

TITLE: Microlight Airworthiness Approval Note 2336: Shadow Fuel Tank Deterioration

Reference: BMAA Service Bulletin 2336 Issue 1
Title: Fuel Tank Deterioration
Applicability: All BMAA-administered Shadows
Author: Adrian Jones, Design Approval Engineer, BMAA
Effective date: 21 March 2011
Classification: Essential

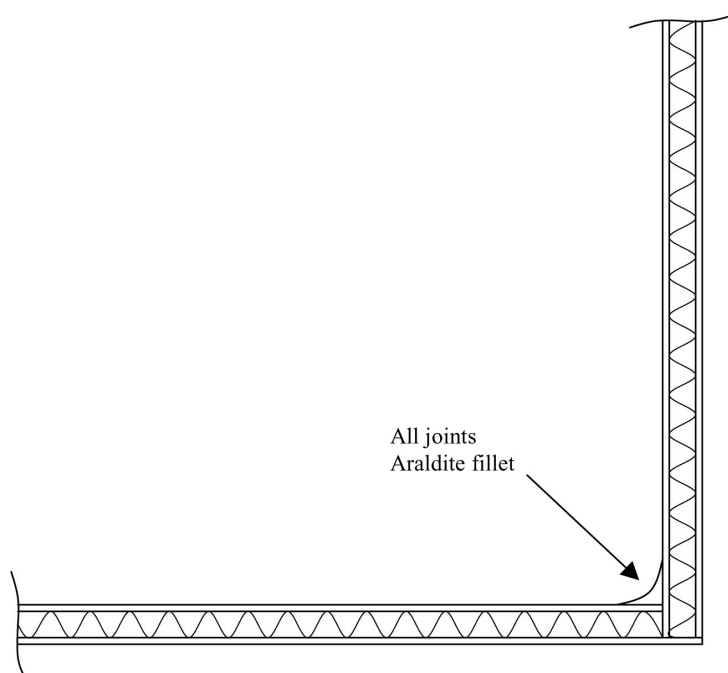
They are constructed from flat 1/8" thick panels, rebated and bonded together at their edges with epoxy. Figure 1 shows a typical edge joint showing a neat fillet of epoxy. After assembly, but before the top is bonded on, the interior of the tanks is coated with a thin layer of epoxy. The fuel outlet hole is then screened by a plastic 'tea strainer' bonded onto the floor of the tank. After bonding on the top a small amount of epoxy is poured into the tank to coat the top panel. It is not possible to neatly fillet the top edge joints as with the rest of the tank.

Figure 1: Shadow Fuel Tank Construction

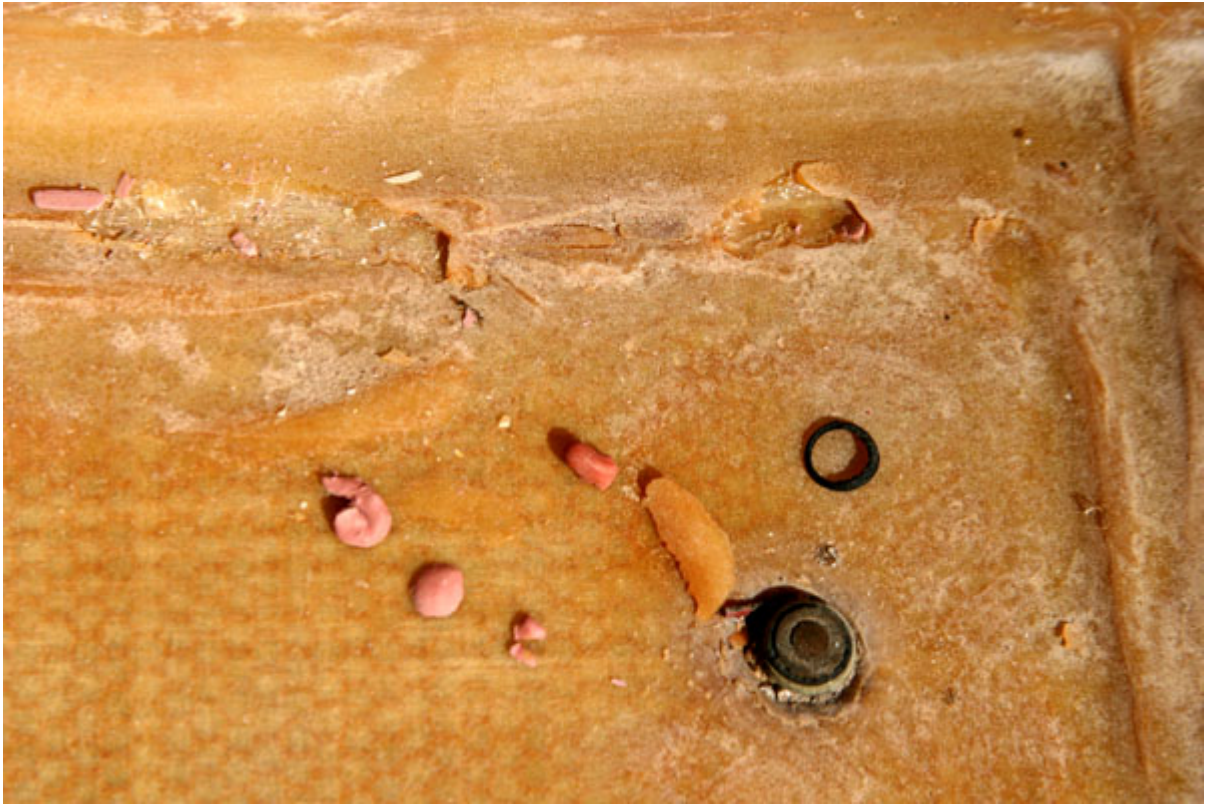
In a number of examples the tanks have developed leaks at the bonded edges. Also fragments of epoxy have been found and the strainer has become dislodged. In one known case the strainer gauze had disintegrated leading to an engine failure, due to debris entering the fuel line. See Figures 2 & 3. Both the main and slipper tanks have been affected.

It is thought that the deterioration of the tanks and strainers is partly a function of the age of the fleet but mostly the introduction of ethanol into fuel in recent years. This is born out by a very thorough scientific study commissioned by the American boating magazine, Seaworthy, published by the US Marine Insurance Industry. This can be found at <http://www.boatus.com/seaworthy/fueltest.asp#>.

Once the tank has developed a leak it is very difficult to carry out a lasting repair since the joints will have been contaminated with 2-stroke oil. Also without removing the top panel, which is a recognised way of opening up the tank, it is impossible to repair the joint fillets effectively from the inside, or to replace the strainer. Removing the top panel is difficult to do without damaging the edges of both the top and sides of the tank.

Figure 2: Debris and Deterioration of Edge Joint

As part of the *daily inspection* the fuel tanks should be checked externally for leaks. The colour imparted to the fuel by the 2-stroke oil often leaves an obvious trail. Otherwise use of a tissue will confirm any suspicion of a leak at a seam. The aircraft should not be flown with a leaking fuel tank.

At the same time check for the presence of any particles of epoxy or other debris in either tank. If any are found they should be flushed out with clean fuel until no loose debris remains. Ensure that this is done in an open, well-ventilated area away from any possible source of ignition.

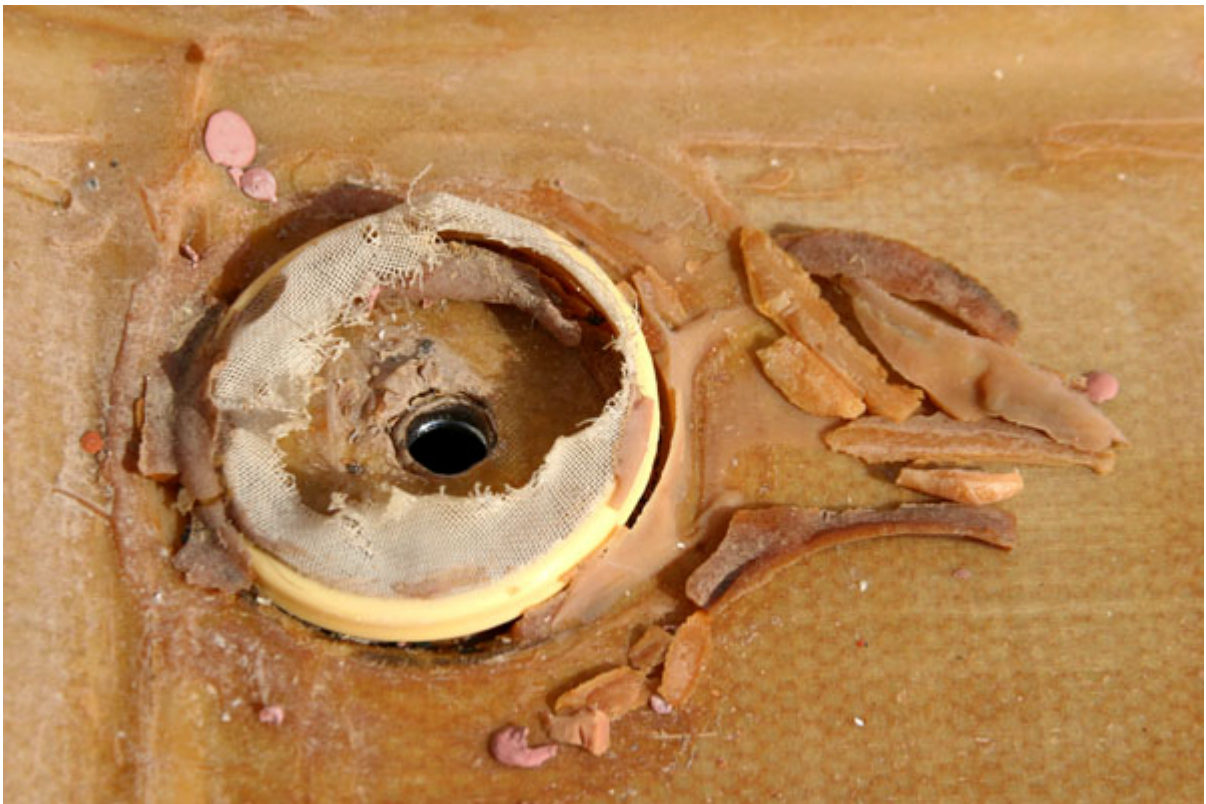
Figure 3: Debris and Strainer Disintegration

Within **10 flight hours or 3 months** of the effective date (whichever is sooner), and then at least every **50-flight hours or annually** (whichever is sooner), check that the fuel strainer in the main tank, and the slipper tank if fitted, is intact and bonded in place, and that it is effective at straining out any particles in the fuel. For the main tank, shine an LED torch into the filler neck, but remember to turn it on and off away from the tank to eliminate the possibility of sparks igniting the fuel. For the slipper tank, remove the fuel gauge sender unit and inspect the strainer through the aperture. The aircraft should not be flown if a strainer is not doing its job effectively.
