SERVICE BULLETINNO. 5DATE 3.12.87CFM METAL-FAX LTD CONSIDERSCOMPLIANCE - ~~Mandatory~~/Recommended/~~Optional~~
(delete which is not applicable)

<u>SUBJECT</u>	AILERON CONTROL ROD ENDS
<u>MODELS AFFECTED</u>	All Models - CFM SHADOW
<u>SERIES NOS. AFFECTED</u>	B and B-D
<u>COMPLIANCE TIME</u>	As soon as possible
<u>PURPOSE</u>	To reduce wear on the threaded Rod Ends - RM 3U - (part no. CM42), which connect the aileron push/pull tube (part no. W153) to the aileron control horn on the control surface, and the threaden inserts (part no. W189) which are held by rivets into the aileron push/pull tube.
<u>INSTRUCTIONS</u>	Remove the rod end, RM 3U, ((1) each control surface) and apply LOCTITE 242e or equivalent to the rod end and re-install.
<u>MATERIAL REQUIRED</u>	LOCTITE 242e or equivalent.
<u>AVAILABILITY OF PARTS</u>	Not applicable.
<u>EFFECTIVITY DATE</u>	
<u>SUMMARY</u>	The wear on the Rod End is caused by the Rod End rotating in the insert with aileron movement.
<u>NOTES</u>	Make sure that the Rod End is re-installed in the aileron push/pull tube in the same position as before it was removed.

SERVICE BULLETIN No.: 12
ISSUE: 1
DATE: 14/07/98

Service Bulletin #14

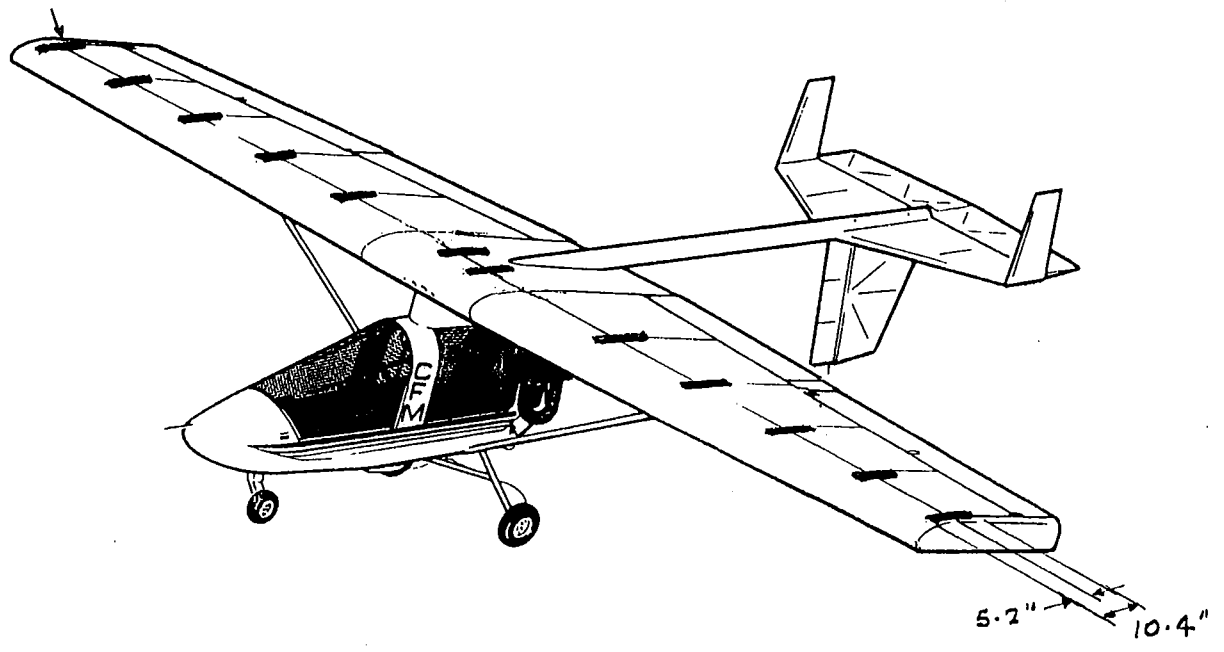
SERVICE BULLETIN N° 7

<u>SUBJECT</u>	SOLAR HEATING OF UPPER WING SURFACES COLOURED OTHER THAN WHITE
<u>MODELS AFFECTED</u>	SHADOW SERIES B, B-D, C, C-D, STREAK SHADOW SERIES S-A1, S-A
<u>SERIAL NOS. AFFECTED</u>	ALL SERIAL NUMBERS
<u>COMPLIANCE TIME</u>	IMMEDIATE
<u>PURPOSE</u>	TO ELIMINATE POSSIBLE STRENGTH DEGRADATION DUE TO HEAT BUILD-UP WHILST AIRCRAFT IS EXPOSED TO SOLAR RADIATION.
<u>INSTRUCTIONS</u>	ON UPPER WING SURFACES ONLY, AT 'D' BOX TO TRAILING RIB JUNCTURE, APPLY WHITE PAINT /REFLECTIVE STRIPS (10.4" LONG) EQUALLY SPACED, FORE AND AFT TO 'D' BOX SKIN AND THE TOP OF THE TRAILING RIB. ENSURE SURFACE IS FREE FROM DUST, DIRT OR GREASE BEFORE APPLYING STRIPS.
<u>MATERIAL REQUIRED</u>	ALUMINIUM FOIL REFLECTIVE TAPE, REF. 6930, 50mm x 3.2m (MANUFACTURED BY 3M) OR WHITE PAINT
<u>AVAILABILITY OF PARTS</u>	CFM OR LOCALLY OBTAINED.
<u>EFFECTIVITY DATE</u>	11.6.90
<u>SUMMARY</u>	
<u>NOTES</u>	THIS IS A PRECAUTIONARY MEASURE AGREED WITH THE C.A.A. WHILST CFM CONDUCT TESTS UNDER SPECIFIC CONDITIONS. NO SERVICE HISTORY OF FAILURE OR SOFTENING OF THE COMPOSITES HAS BEEN EXPERIENCED TO DATE. COMPLIANCE WITH THIS SERVICE BULLETIN SHOULD BE RECORDED AND CERTIFIED IN THE AIRCRAFT LOG BOOK.

2" STRIP REFLECTIVE ALUMINIUM TAPE
(12) PLACES

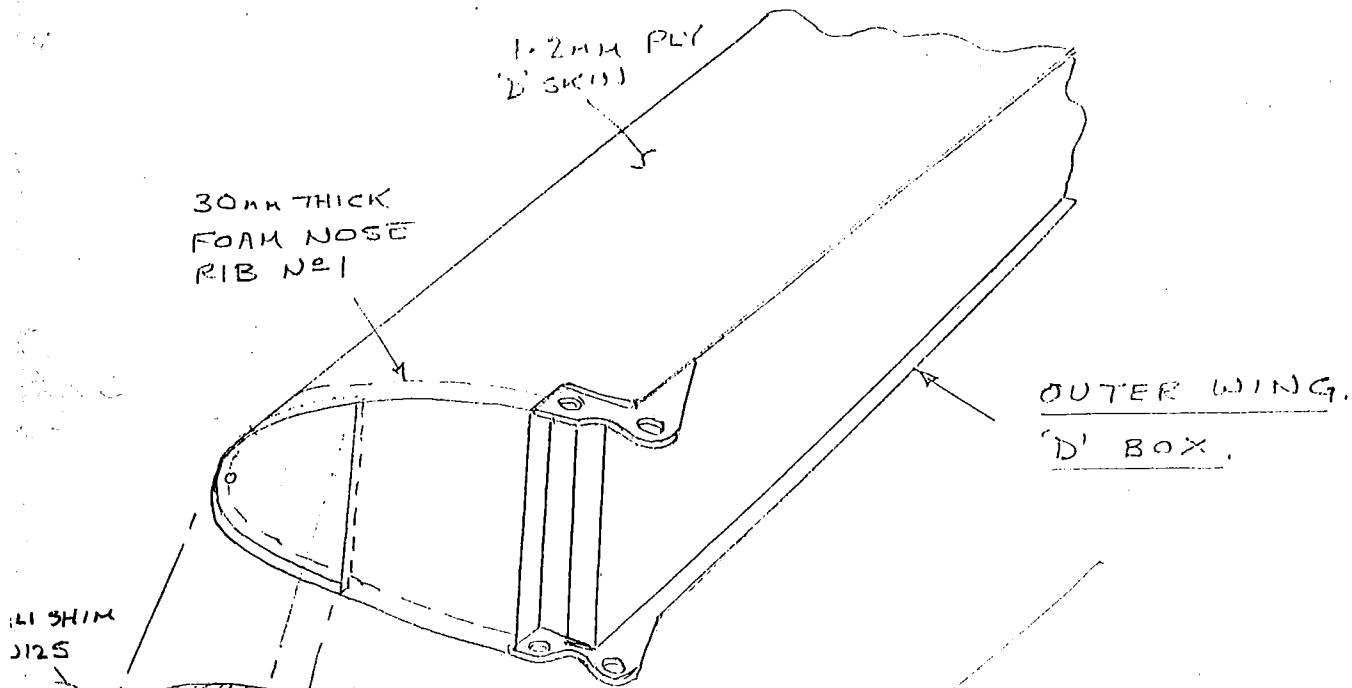
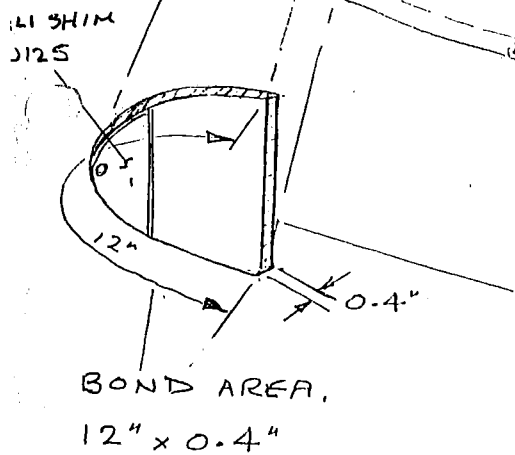
<u>SUBJECT</u>	FORE/AFT WING MOVEMENT
<u>MODELS AFFECTED</u>	B/B-D, C/C-D, S-A/S-AI, SA-M, SS.
<u>SERIES NOS. AFFECTED</u>	ALL SERIAL Nos. EXCEPT D/D-D
<u>COMPLIANCE TIME</u>	NEXT RENEWAL OF PERMIT
<u>PURPOSE</u>	TO PROVIDE FOR ANTI DRAG FORCES AT INNER/OUTER WING JUNCTURE - D BOX NOSE SECTION.
<u>INSTRUCTIONS</u>	ADD WING NOSE SPAR TO OUTER WINGS. ADD PLY PRESSURE PAD TO CENTRE WING AND OUTER WINGS. SEE SEPARATE INSTRUCTIONS.
<u>MATERIAL REQUIRED</u>	(2) L/E SPINE W243 (4) PAD W240 SHADOW } DEPENDANT ON MODEL (4) PAD W150 STREAK } QUICK SET ARALDITE #2012 300g PACK
<u>AVAILABILITY OF PARTS</u>	CFM METAL-FAX LTD.
<u>EFFECTIVITY DATE</u>	SEPTEMBER 1996
<u>SUMMARY</u>	THIS BULLETIN CAN BE PERFORMED BY:- 1) CFM METAL-FAX LTD. 2) THE SHADOW FLIGHT CENTRE LTD.
<u>NOTES</u>	THE CORRECT GAP BETWEEN CENTRE/OUTER WINGS AT NOSE OF 'D' BOX IS 1 TO 1.5 mm WHEN AIRCRAFT IS RIGGED AND WINGS IN FORWARD PRESSURE (NOSE WHEEL ON TOUCHING GROUND).

REMOVE W125 OFF NOSE FOAM RIB - OUTER AND CENTRE WINGS.
 ON OUTER WINGS CUT A SQUARE HOLE JUST SMALLER THAN CROSS SECTION OF W243 AT NOSE L/E.
 PUSH W243 INTO CUTOUT BETWEEN L/E PLY SKIN AND FOAM RIB WITH W243 ABRASIVE SIDE TO FOAM.
 WORK INWARDS UNTIL 10-12MM PROTRUDES. WITHDRAW, REMOVE ABRASIVE.
 APPLY ABRASIVE TO PLY L/E SIDE AND PUSH UNTIL END IS FLUSH WITH FOAM RIB.

SHIM 10MM THICK IS REDUCED IN THICKNESS WHICH WHEN W125 IS ADDED THE TOTAL THICKNESS IS FLUSH WITH L/E PLY EDGE.

SHIM 10MM THICK IS REDUCED - IF NECESSARY TO BE FLUSH WITH L/E PLY EDGE.
 W125 IS ADDED BY ITS THICKNESS PROUD OF EDGE. (THIS SETS WING GAP)

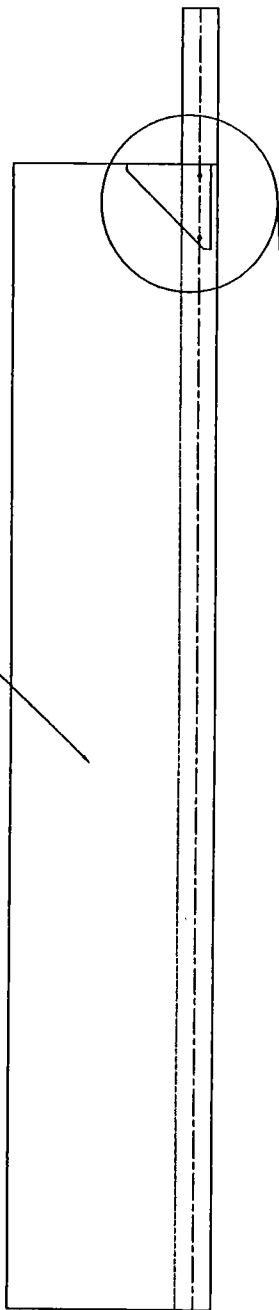
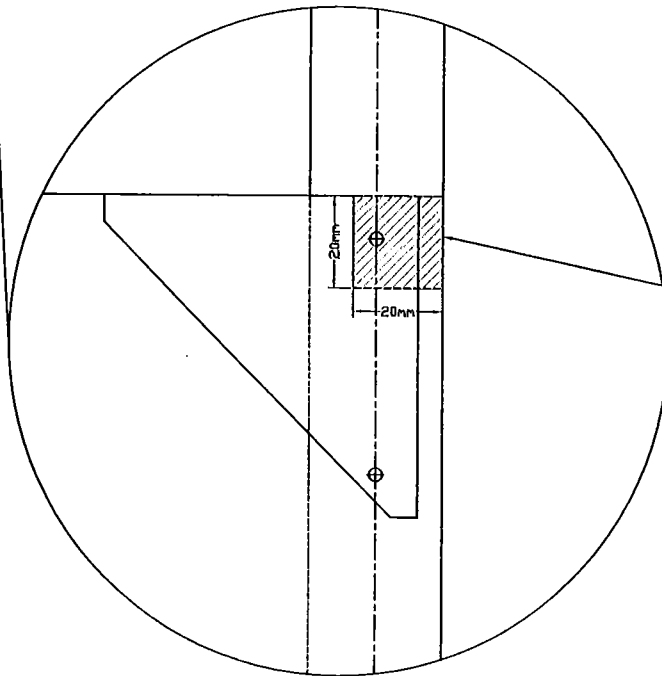
FIN
ASSEMBLY

SUBJECT	Rudder Fin Post			
MODELS AFFECTED	B, C & D Series Shadow, Streak Shadow & Star Streak			
SERIAL Nos AFFECTED	All			
COMPLIANCE TIME	Before further flight			
PURPOSE	To identify possible cracks in the top of the rudder fin post in the vicinity of the top of the rudder fin where the fin post enters the boom tube. Rectify where necessary.			
ACTION	<p>Remove the rudder fin post from the aircraft. Remove a small section of the covering material (20mm x 20mm) on both sides of the fin around the gusset and the fin post itself at the root (see attached drawing). Inspect for cracks. It is not necessary to replace the covering material after inspection provided that the all remaining fabric is fully glued to the surface of the gusset.</p> <p>In the event that a crack is present, the entire rudder fin post (Part T 147) must be replaced prior to further flight with a new Rudder Fin Post Assembly (Part T189)</p> <p>In the event that no crack is present, a strengthening sleeve (Part T 188) must be installed in the top of the fin post, prior to the aircraft's next annual inspection (Modification 40)</p> <p>Record the inspection and replacement/modification in the aircraft logbook</p>

COVERING TO BE
REMOVED FOR
INSPECTION

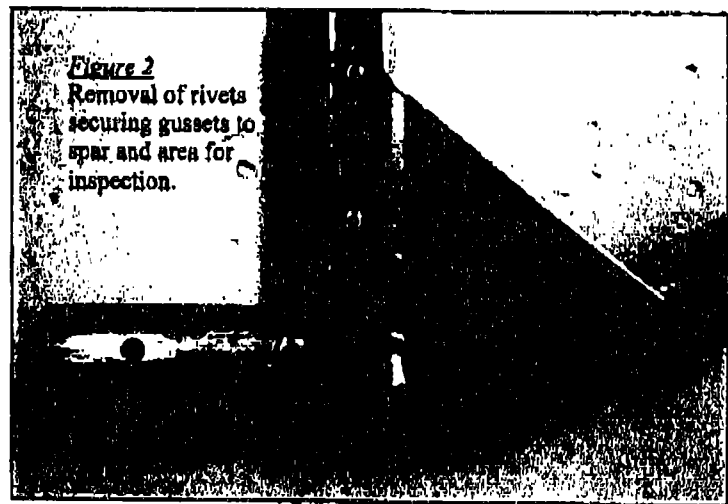
The area for inspection is indicated by the circle in figures 2 & 3.

Using a new 1/8" drill, remove the heads of the rivets, which attach the gussets to the leading edge of the tailplanes. Take care not to oversize the holes in the tubes. See Figure 2.

On the right hand tailplane, the gussets & channel shaped root rib can now be moved sufficiently out board, to facilitate inspection of the tube area beneath T121.

Do not move the end of the root rib by more than is necessary for inspection (10-15mm) as excessive movement could damage the trailing edge fixings.
