SAFETY SPOT

With **Malcolm McBride**
Airworthiness Engineer

Extract about
'Rudder Fin Post cracking'
from ***Light Aviation***
magazine (July 2013)

STREAK SHADOW FAILED FIN POST

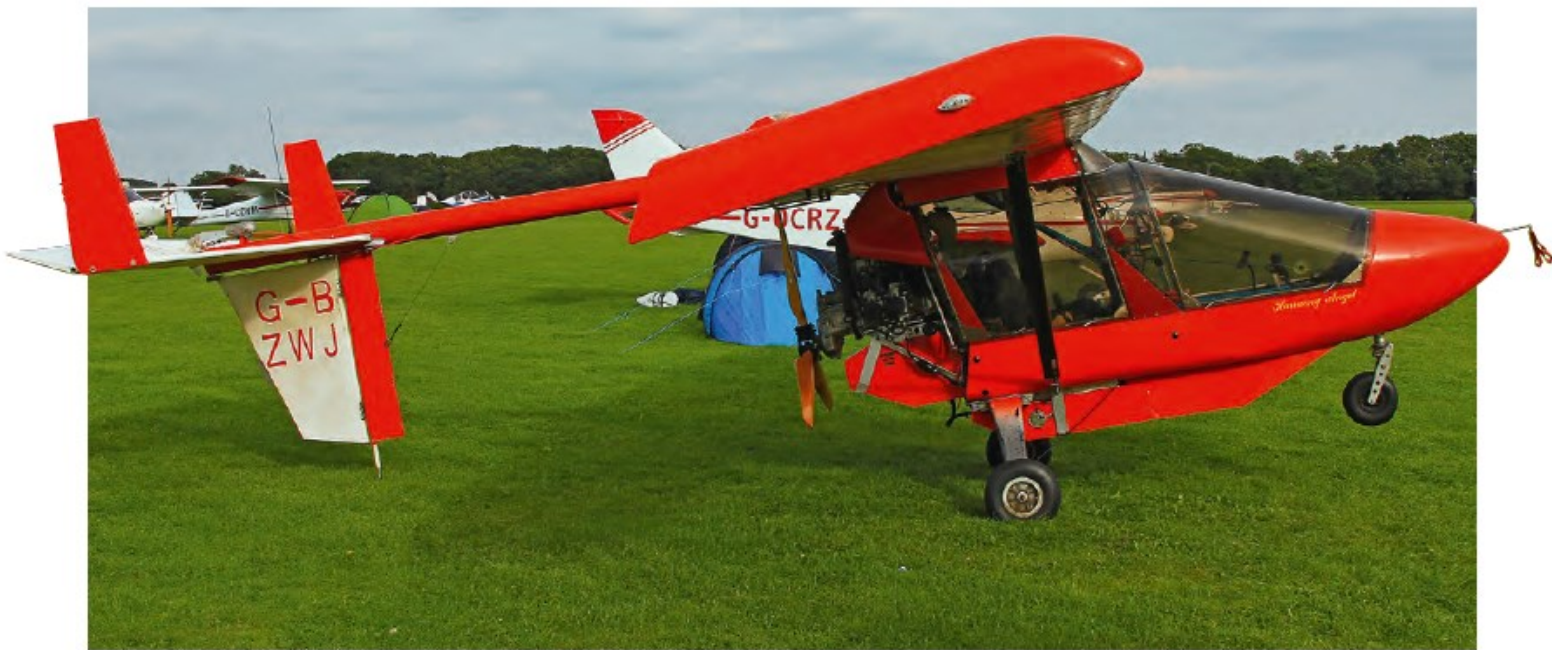
Because of the nature of the design, the Shadow series of aircraft rest on their tail when the pilot's weight is removed; you can see that it would be easy to inadvertently impart quite large loads through the fin post into the fuselage boom and it's definitely worth taking this into account when pull starting the engine. (Photo: Richard Hamblyn)

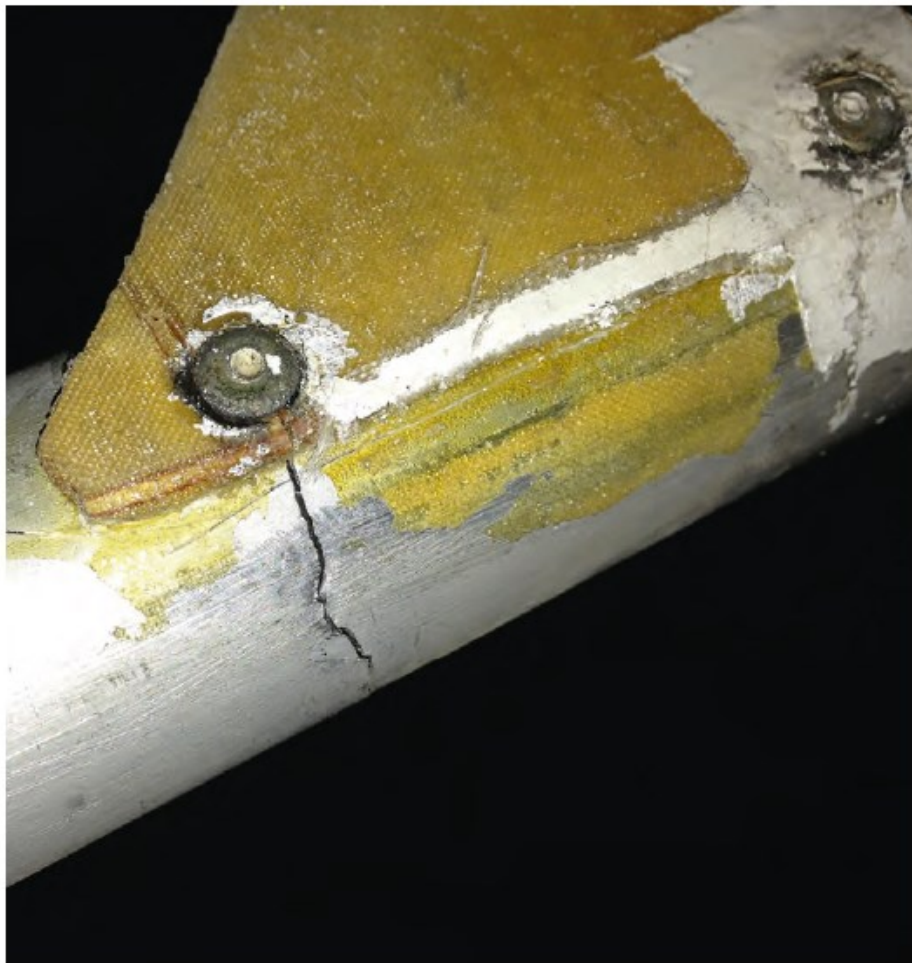
Here's the reason why a good walk-round inspection could prevent a good day from becoming a bad one. This is a picture of the Fin Post (less the fabric covering) from a Streak Shadow complete with a nasty crack near the point where the fin post enters the fuselage boom. The owner only noticed it because he felt an unusual movement in the fin... well done to him for having a good feel. Humour, such as it is, aside... I think that it's always a good idea to have a good pull and prod on bits of the aircraft to check whether one bit is moving correctly against another and to detect whether there's movement where there shouldn't be. (Photo: Fiona Luckhurst)

Attached photos of the Fin Post (T147) from a Streak Shadow showing cracks found by the owner when he noticed an unusual movement in the fin post when he was preparing for flight. Historically MPD 1998-013 R1 was raised after cracks had appeared at the top of the fin post where it enters the boom and mandated the fitting of the additional inner sleeve. The inner sleeve (T188) is intact in this case and has done its job.

Interestingly, the failure on this fin post was not at the top by the first line of rivets securing the wooden gusset as had been seen before but at the second, lower, set of rivets. This machine has flown nearly 700 hours and has a Rotax 618 fitted. This is a heavier engine than the standard R582. She also has a fixed rudder trim which was found to be very loose on inspection the week before. (A possible suspect for the unusual damage?)

Certainly a crack like this is serious as progression of the crack could lead to the complete fin and rudder assembly separating from the aircraft. The Streak is a famously benign handling aircraft, but losing the fin and rudder would be likely to result in pretty disastrous directional instability. We discussed this failure at one of our regular engineering meetings and the Chief Engineer suggested that I ask the aircraft's designer, another old friend, David Cook, what he thought about it.

“I agree with Francois,” David explained, “and it wouldn't be good if a pilot lost his fin, that's why we reinforced it with the extra internal tubework early on.” David continued, “I think that it's most likely that the reason for this fatigue failure is that, either the aircraft sits outside and is being blown from side to side by the wind or, and this is the most likely, the owner is starting the aircraft with the tail still on the ground.”

We'll be discussing the way forward with this issue at the next Airworthiness Review Meeting, but meanwhile this cracking does provide a timely reminder of the need for careful pre-flight checks and always being on the alert for anything that doesn't look or feel as it should, especially with the very lightweight structures on microlight and similar airframes which, designed for flight loads, may not be too tolerant of ground abuse.
