SHADOW HANG BRACKET

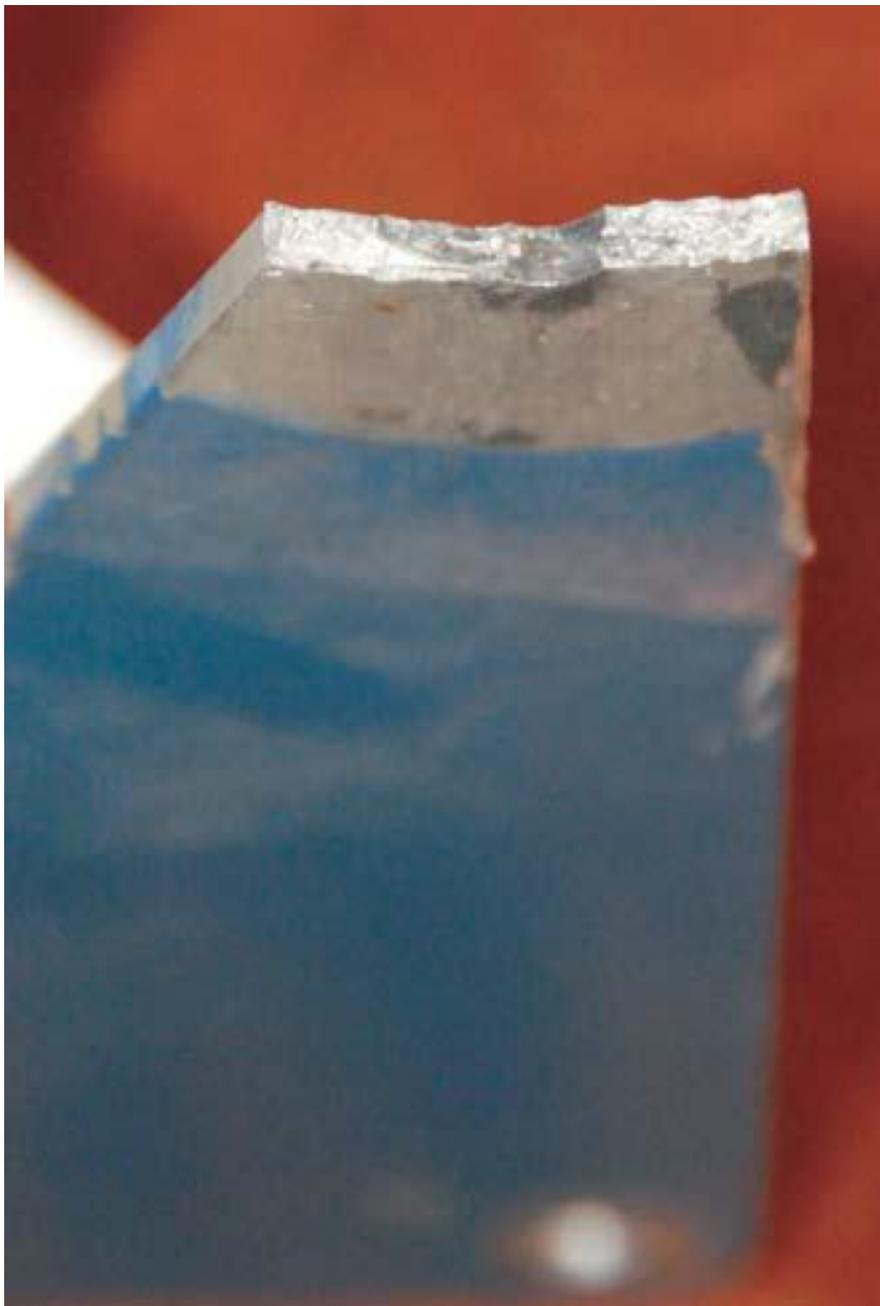
Anyway, I digress. The bracket in the picture was sent in by another Inspector, David Bremner (thanks David). He is rebuilding a Shadow that suffered a heavy landing and required the boom to be changed; he noted the broken bracket and, quite naturally, put the break down to the heavy landing. David remembered that there is a PFA Airworthiness Information Leaflet (PFA/MOD/161/001) requiring a thorough check of this bracket at each Permit Renewal, so he took a closer look at it.

▲ Shadow hang bracket

If you've ever flown a Shadow you will know that cross-wind landings put a fairly large, i.e. noticeable, twisting moment through the airframe. David Cook told me that he was able to turn with a sort of 'lurching' manoeuvre through 360 degrees without using bank. To reduce this fuselage twist CFM introduced a mod that stabilised these two front hang brackets, it consisted of a plywood gusset set between the two brackets. It is possible that movement in this bracket over the years has caused the work hardening; one thing for sure is that it is this bracket that holds the body of the aircraft to the fuselage boom and I would not want it to break when I was flying the aircraft. The aircraft that the broken bracket came from had not been fitted with the recommended gusset.

However, after a very heavy landing (code for controlled crash!) in any type of aircraft it is essential to have a thorough check, and this includes taking panels off if necessary, to look around spar attachments. Do not forget things like engine mounts or exhaust supports. Pay particular attention to support structures holding heavy items. Things like fire extinguishers and batteries are often forgotten.

I shall be writing to all LAA Shadow operators reminding them of the annual requirement to check this bracket and requiring them to incorporate CFM MetalFax Mod Number 9, which is the plywood gusset.
