BRITISH MICROLIGHT AIRCRAFT ASSOCIATION SERVICE BULLETIN

Reference: BMAA Service Bulletin 2613 issue 1
Title: Shadow lift-strut cracking
Applicability: All Shadow B/BD, C/CD and D/DD Series aircraft
Author: Ben Syson, BMAA
Effective date: 19 May 2016
Classification: Essential, Advisory Service Bulletin

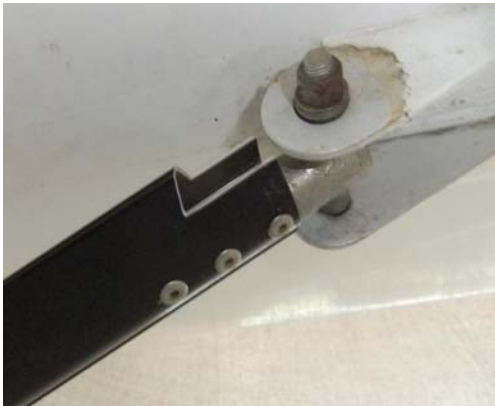
Figure 1: top of lift strut and wing attachment

This Service Bulletin is to advise owners of BMAA Shadow aircraft of the potential for cracks at the top of the lift struts in the region shown in figure 1.

Carefully inspect the lift struts for cracks as part of every Daily inspection. If any cracking is found do not fly the aircraft and report to the BMAA Technical Office - for our information and a technical assessment. If repairs are necessary to a Shadow with a Permit to Fly, these must be approved by the Technical Office.

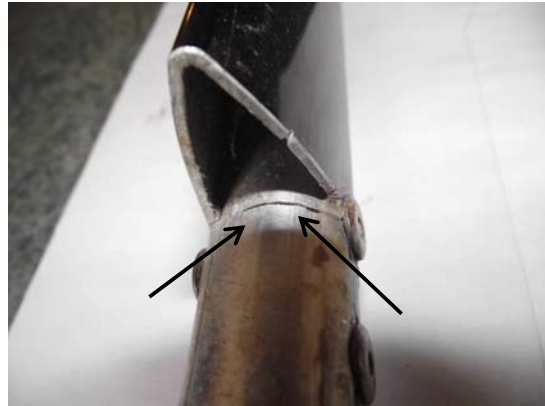
Figure 2: large crack on lift strut

A very serious crack was found in the top of a lift strut on a Shadow that is currently being operated as a single-seat deregulated (SSDR) Microlight. See Figure 2.

It is suspected that cracking of the top of the lift strut is primarily due to trailing with the lift struts attached to the wings, rather than due to flight loads.

However, once cracks have started they can grow under flight loads, and once long enough will cause catastrophic in-flight failure.

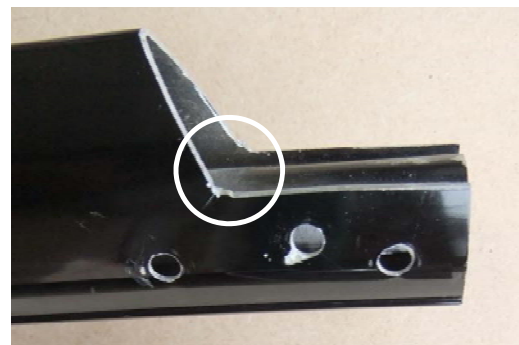
Figure 3: cracks on lift strut

Although the lift strut on this SSDR does not appear to be entirely standard, cracking has also been observed on a standard lift strut. See Figure 3.
