THE IMPORTANCE OF A GOOD INSPECTION

Finding issues before they turn into problems during flight
is at the heart of the LAA inspection programme

SHADOW SERIES CD

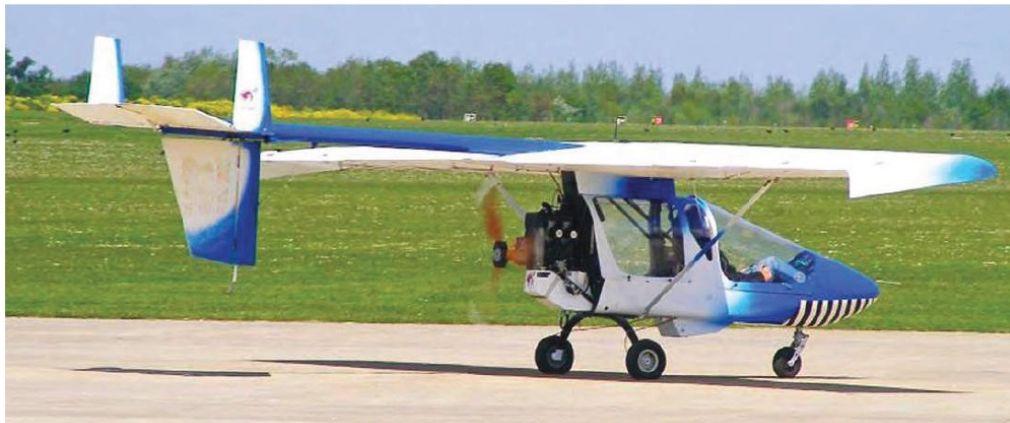
(Left) The new owner of a Shadow noted that the fuselage needed some attention and spent some time in his workshop getting this part of the airframe in tip top condition. When he was happy all was well, he fitted the wings and went off flying. After a few sorties he, and he's not sure why, decided to look closely at the strut/wing connection; he nearly had a heart attack when he saw this crack... a very lucky escape.

I have to say, not normally being lost for words, that I've been staring at the file on this event for ten minutes. I am still flummoxed how a wing strut attachment could be cracked through about 50% of its effective diameter and not have been spotted during a number of different earlier inspection points.

So, what's happened here? Well, working backwards, the aircraft had flown as an SSDR on a number of occasions post-refurb, but clearly no thorough pre-flight checks had been carried out. The owner agrees that, had they have been, he would have spotted the cracks in the strut fitting.

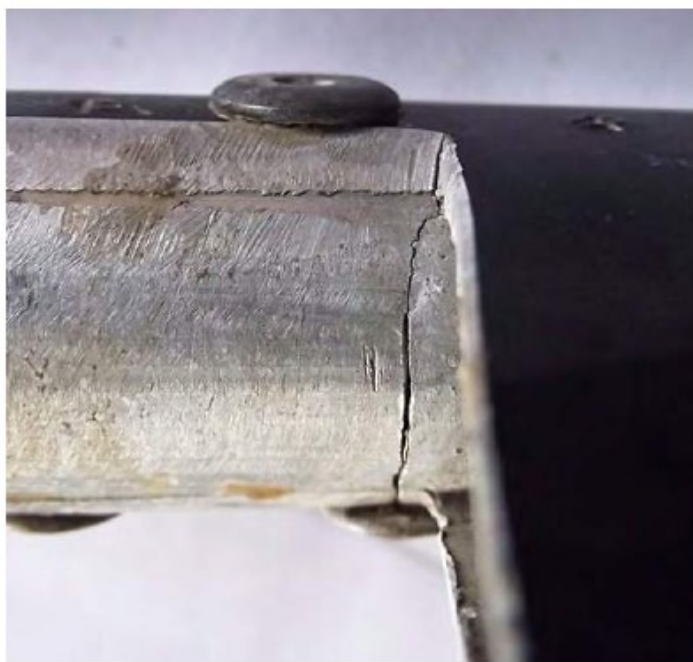
(Right) Taking a closer look at the failed Shadow top strut I hope that you can see that this part has been bodged by somebody in the past, notice the centre punch mark and the generally poor condition of this critical part.

I am absolutely certain that these bodged fittings wouldn't have passed muster had this particular owner seen them, regardless of whether they were cracked or not. For some reason in the past, though not recorded in the airframe logbooks (not much was), somebody with no engineering knowledge at all was let loose with a drill, a junior hacksaw and a pop rivet gun.

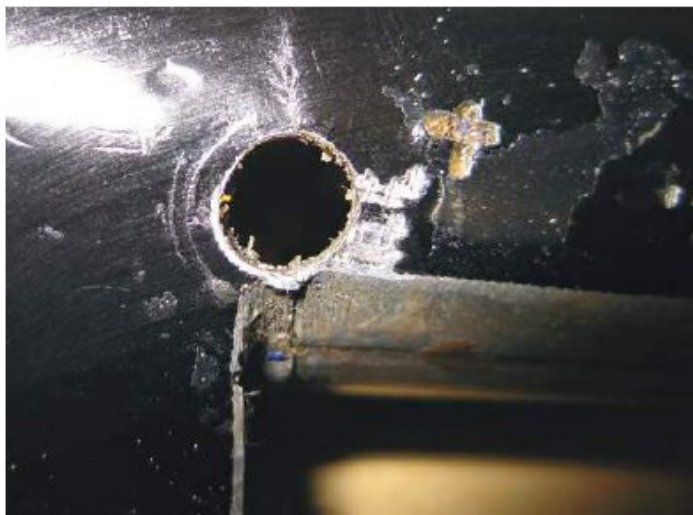
(Right) Working with Shadow expert Fiona Luckhurst and the BMAA technical office, it became clear that the failed strut had not been made to drawing. The top picture is correctly made... but notice the horribly sharp corner in the cut-out which is far from good engineering practice, especially in highly stressed areas of a component. The lower picture, from the BMAA library, shows a small crack emanating from the same, albeit slightly tidier, corner.

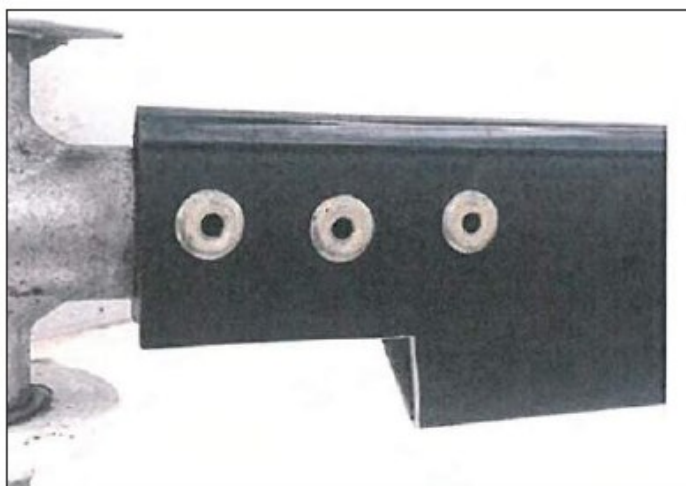
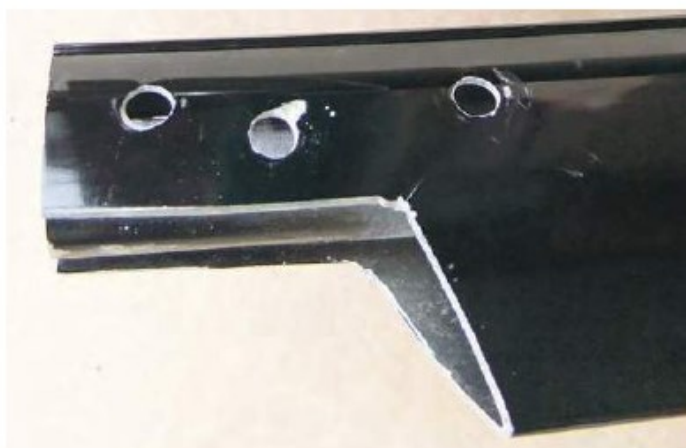
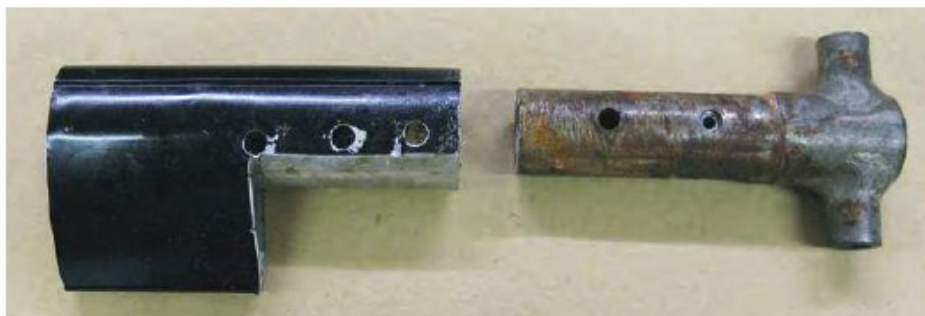
(Above and below) When we received the Shadow strut-end here at Turweston, we drilled out the rivets and dismantled the assembly. The two parts needed some persuasion to come apart but, when they did, the method of construction became clear. The pictures show the two components and the end fitting is both glued (epoxy) and riveted in place. The problem with this is that corrosion products from the steel fitting have broken the joint's adhesion over time and, because ferrous oxide occupies a greater volume, increased the stresses in the aluminium strut.

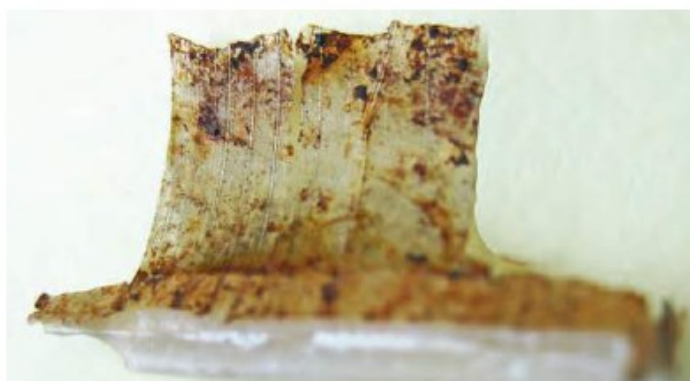
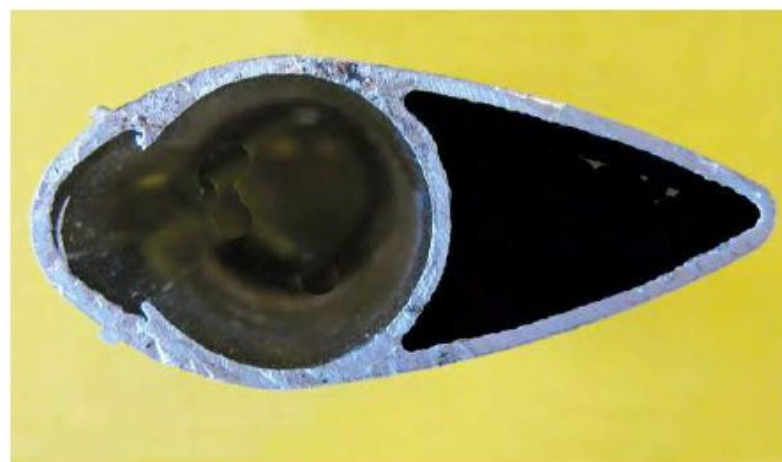
(Above) The Shadow strut is manufactured from an extrusion and, thinking of introduced stress caused because of an over-tight end fitting, I decided to measure the items. The picture above shows the cut end of the strut. I noticed immediately that the strut end fitting wouldn't slip inside the extrusion and measurement showed why – the inside diameter of the extrusion was 0.22 mm smaller than the cleaned strut end! *(Photo Malcolm McBride)*
