SERVICE BULLETINNO. 5DATE 3.12.87CFM METAL-FAX LTD CONSIDERSCOMPLIANCE - ~~Mandatory~~/Recommended/~~Optional~~
(delete which is not applicable)

<u>SUBJECT</u>	AILERON CONTROL ROD ENDS
<u>MODELS AFFECTED</u>	All Models - CFM SHADOW
<u>SERIES NOS. AFFECTED</u>	B and B-D
<u>COMPLIANCE TIME</u>	As soon as possible
<u>PURPOSE</u>	To reduce wear on the threaded Rod Ends - RM 3U - (part no. CM42), which connect the aileron push/pull tube (part no. W153) to the aileron control horn on the control surface, and the threaden inserts (part no. W189) which are held by rivets into the aileron push/pull tube.
<u>INSTRUCTIONS</u>	Remove the rod end, RM 3U, ((1) each control surface) and apply LOCTITE 242e or equivalent to the rod end and re-install.
<u>MATERIAL REQUIRED</u>	LOCTITE 242e or equivalent.
<u>AVAILABILITY OF PARTS</u>	Not applicable.
<u>EFFECTIVITY DATE</u>	
<u>SUMMARY</u>	The wear on the Rod End is caused by the Rod End rotating in the insert with aileron movement.
<u>NOTES</u>	Make sure that the Rod End is re-installed in the aileron push/pull tube in the same position as before it was removed.

SERVICE BULLETIN No.: 12
ISSUE: 1
DATE: 14/07/98

Service Bulletin #14

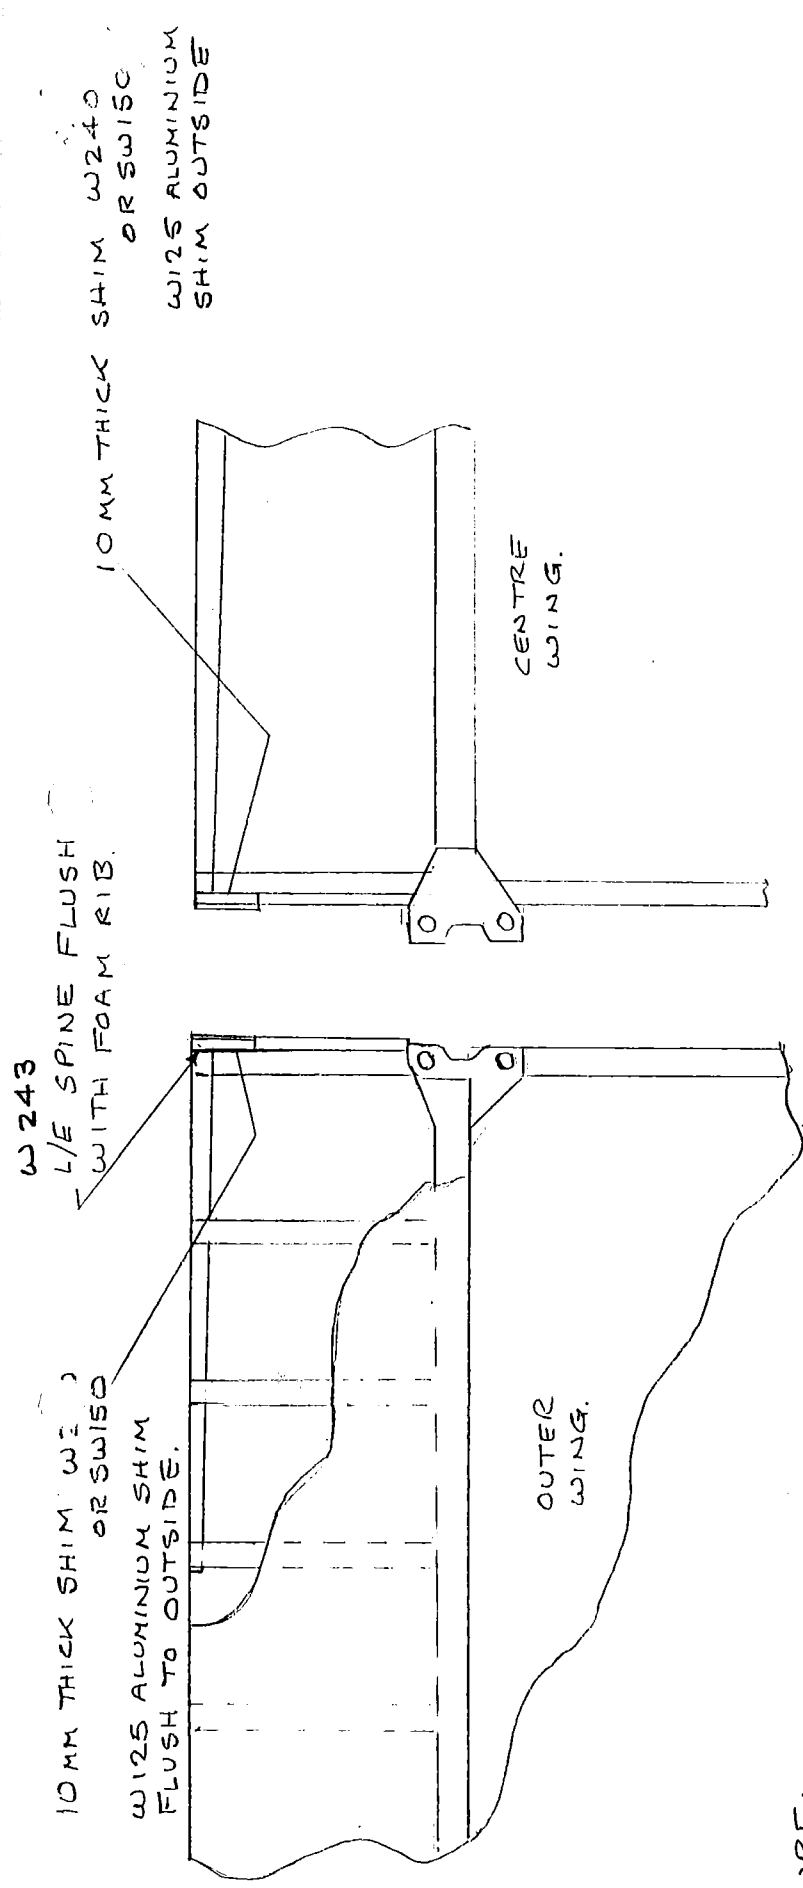
<u>SUBJECT</u>	FORE/AFT WING MOVEMENT
<u>MODELS AFFECTED</u>	B/B-D, C/C-D, S-A/S-AI, SA-M, SS.
<u>SERIES NOS. AFFECTED</u>	ALL SERIAL Nos. EXCEPT D/D-D
<u>COMPLIANCE TIME</u>	NEXT RENEWAL OF PERMIT
<u>PURPOSE</u>	TO PROVIDE FOR ANTI DRAG FORCES AT INNER/OUTER WING JUNCTURE - D BOX NOSE SECTION.
<u>INSTRUCTIONS</u>	ADD WING NOSE SPAR TO OUTER WINGS. ADD PLY PRESSURE PAD TO CENTRE WING AND OUTER WINGS. SEE SEPARATE INSTRUCTIONS.
<u>MATERIAL REQUIRED</u>	(2) L/E SPINE W243 (4) PAD W240 SHADOW } DEPENDANT ON MODEL (4) PAD W150 STREAK } QUICK SET ARALDITE #2012 300g PACK
<u>AVAILABILITY OF PARTS</u>	CFM METAL-FAX LTD.
<u>EFFECTIVITY DATE</u>	SEPTEMBER 1996
<u>SUMMARY</u>	THIS BULLETIN CAN BE PERFORMED BY:- 1) CFM METAL-FAX LTD. 2) THE SHADOW FLIGHT CENTRE LTD.
<u>NOTES</u>	THE CORRECT GAP BETWEEN CENTRE/OUTER WINGS AT NOSE OF 'D' BOX IS 1 TO 1.5 mm WHEN AIRCRAFT IS RIGGED AND WINGS IN FORWARD PRESSURE (NOSE WHEEL ON TOUCHING GROUND).

PROCEDURE:

REMOVE W125 OFF NOSE FOAM RIB - OUTER AND CENTRE WINGS.
 ON OUTER WINGS CUT A SQUARE HOLE JUST SMALLER THAN CROSS SECTION OF W243 AT NOSE L/E.
 PUSH W243 INTO CUTOUT BETWEEN L/E PLY SKIN AND FOAM RIB WITH W243 ABRASIVE SIDE TO FOAM.
 WORK INWARDS UNTIL 10-12MM PROTRUDES. WITHDRAW, REMOVE ABRASIVE.
 APPLY ABRASIVE TO PLY L/E SIDE AND PUSH UNTIL END IS FLUSH WITH FOAM RIB.

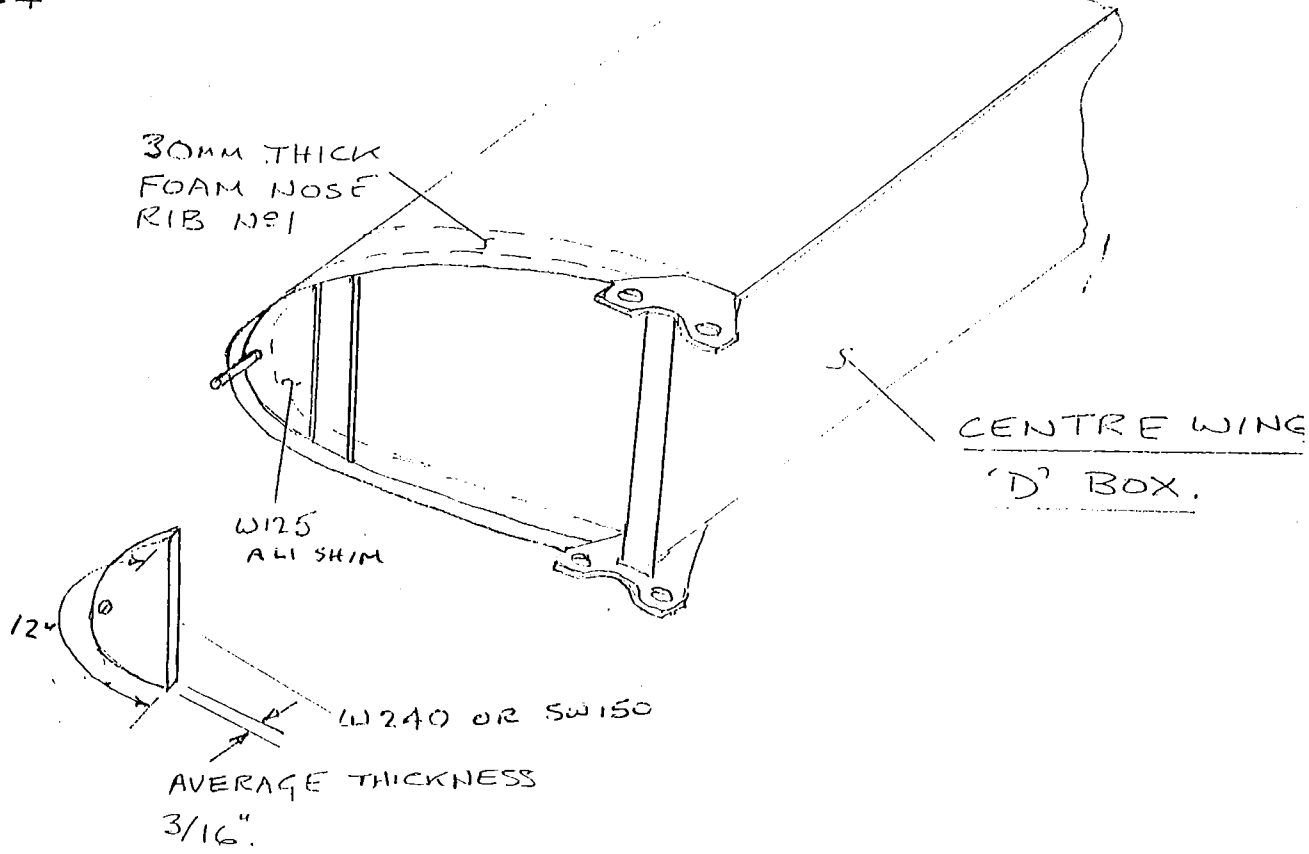
1.2mm PLY
'D' SKIN

30mm THICK
FOAM NOSE
RIB N°1

BOND AREA $8\frac{1}{2}'' \times \frac{3}{16}''$
